Visual Property Inspection

**1 Lakeview Dr Days Beach
Jack Fish Lake, Saskatchewan**

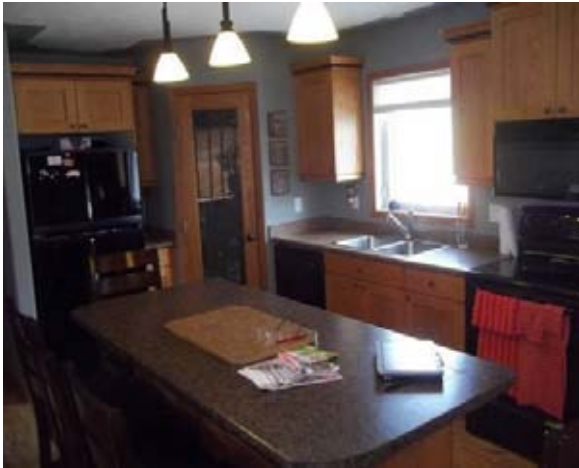
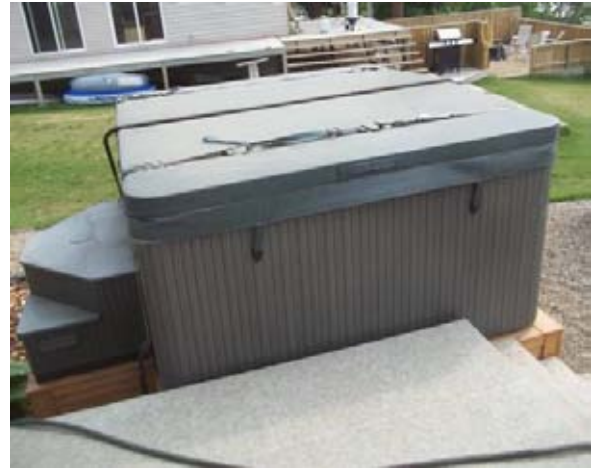
Hot tub exempt from Inspection.

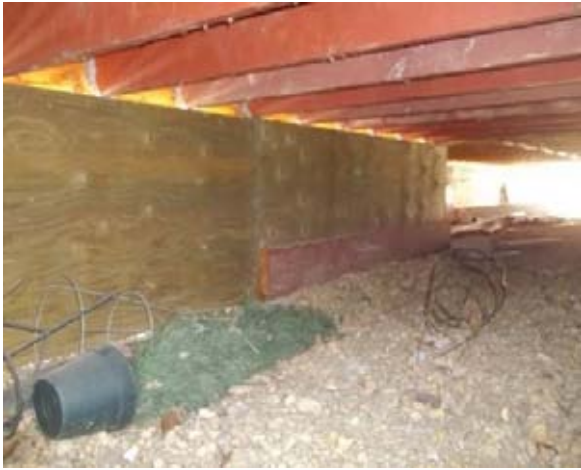
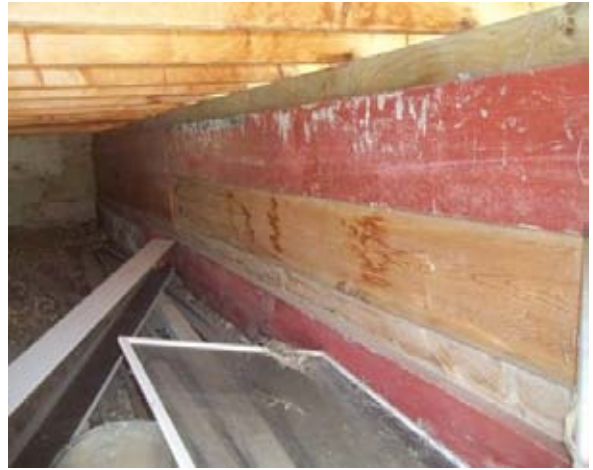
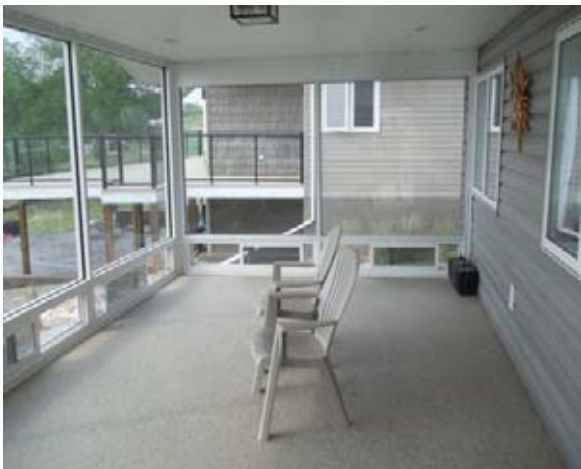
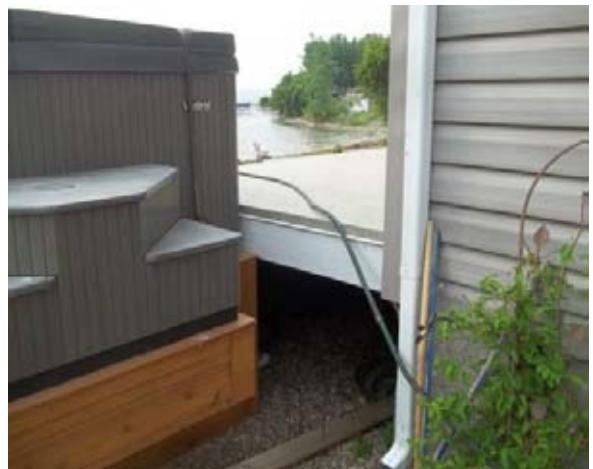
Enclosed sundeck noted. Support structure concealed.

Recommend railing / safety guard.

Install handrail to promote safety

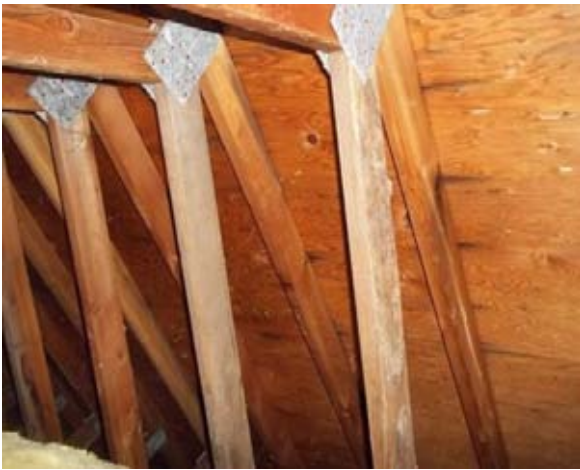
Vermiculite-noted. Possibly contain asbestos. Recommend having tested.

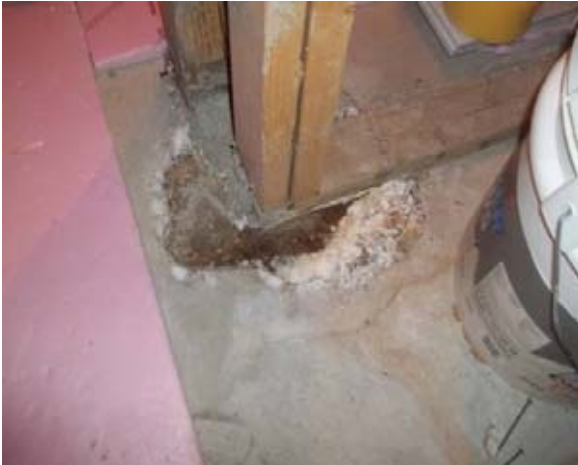
Efflorescence noted. Monitor for further staining and or damages.

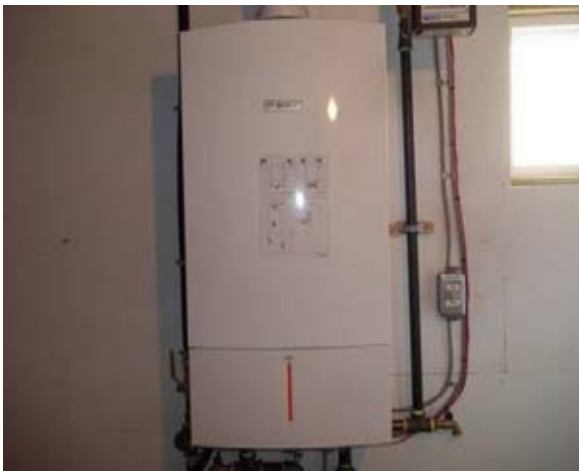
Boiler system noted, supply in floor heat for basement. System shutdown for summer. Recommend reviewing system with plumber for operation.

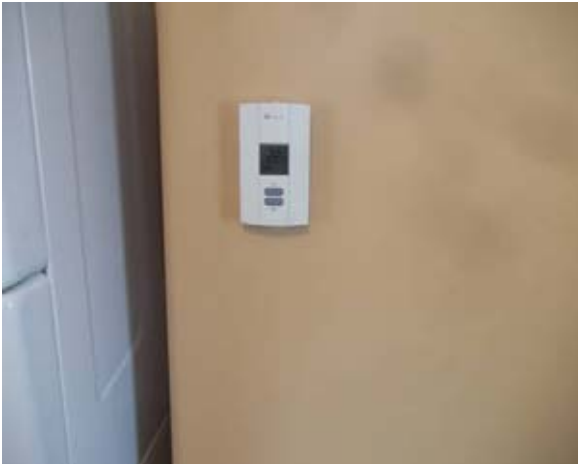
Electric heat noted in foyer. Not tested at time of inspection.
